Examples of Modern Mines that Damaged Rivers & Fisheries

(Compiled by Mara Bacsujlaky, October 2004)

BAIA MARE GOLD MINE, Romania

SUMMITVILLE GOLD MINE, Colorado

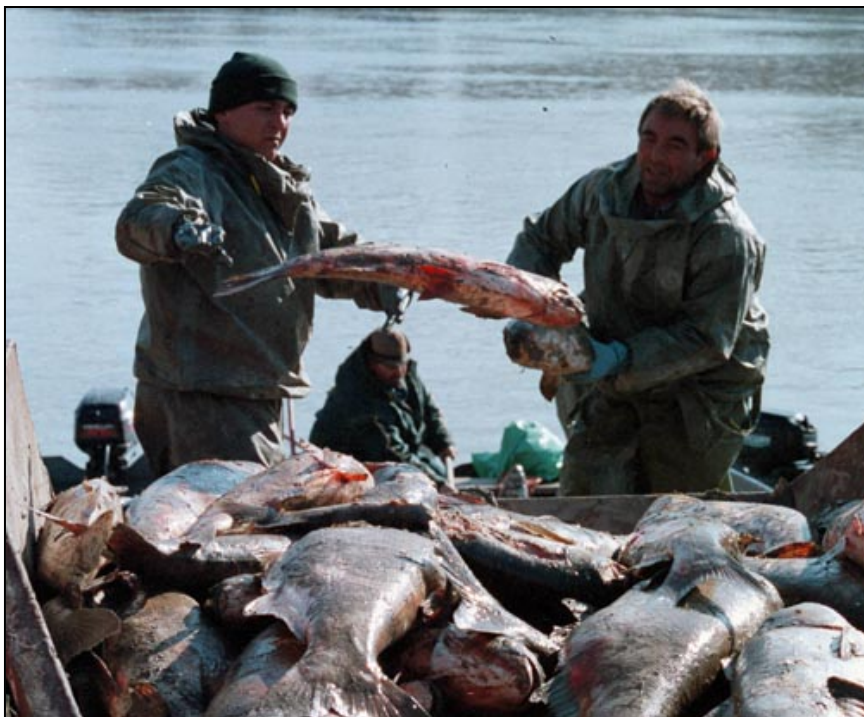
A Hungarian fisherman gathers dead fish from the Tisza River, © Pearson Education, 2000

On January 30, 2000, as a result of snow and rain, water in the tailings impoundment overtopped the dam, resulting in a break in the dam. One hundred and thirty cubic yards of mine waste containing approximately 75 tons of cyanide flowed into the Sasar River, and then into the Somes. The Somes is a branch of the Tisza river, the second largest river in Hungary. All of these rivers are part of the larger Danube River system. In all, over 1,200 miles of the Danube River system were contaminated. The spill threatened the drinking water supplies of 2.5 million people and caused enormous damage to wildlife in Hungary and Yugoslavia. It was estimated that 80% of all fish in the Tisza River died as a result of the spill.

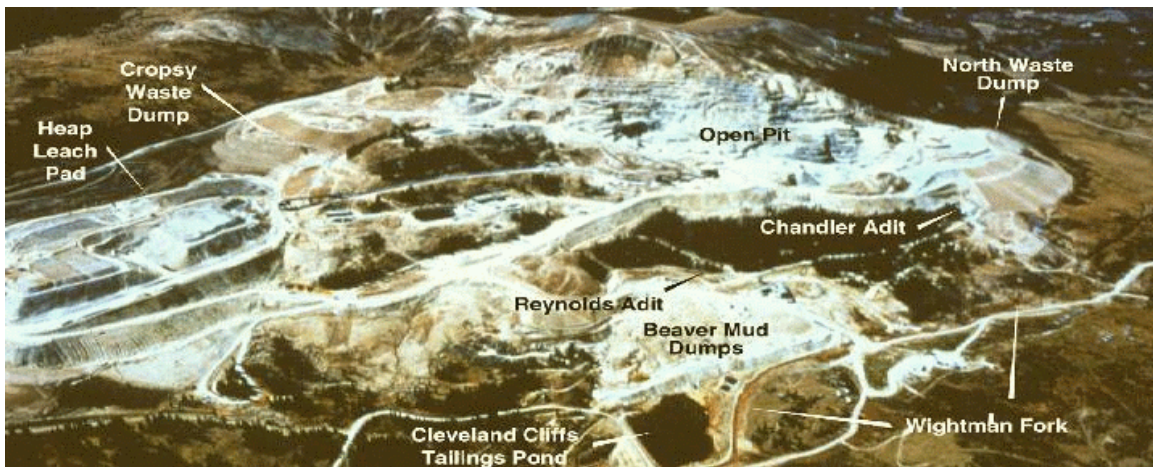
Summitville CO, Oct. 1993, from aerial photo by IntraSearch Inc.
